KEEP STORAGE BAY DRY

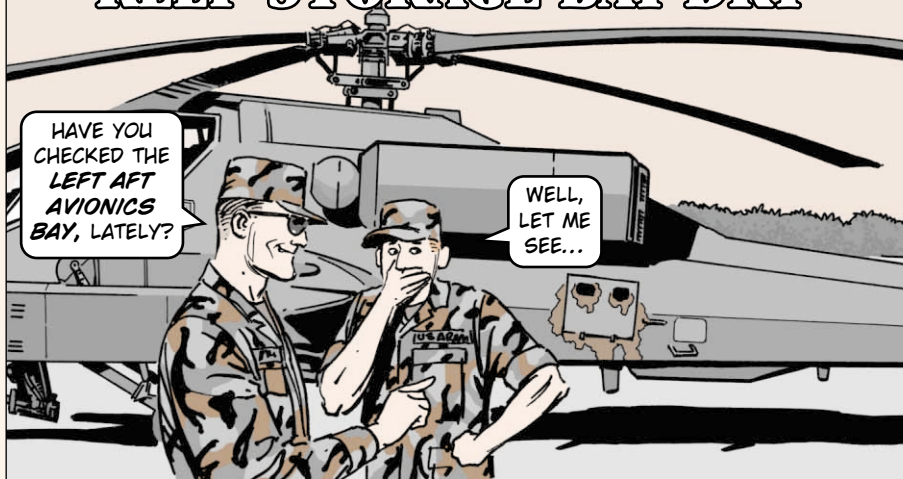
Crew chiefs, MWO 1-1520-238-50-50 moved the AN/AVR-2A(V)1 laser detection comparator and the AN/APR-39A digital processor into the Apache's left aft storage bay (L295) to keep them dry. It worked on the AH-64D, but a water problem still exists on the AH-64A.

That's because on the A model the cable harnesses for those components are routed through holes at stations 285 and 305—now called the left aft avionics bay—which cannot be sealed. So rain water, wash water, condensation and even hydraulic fluid can enter the bay, following the cable bundles. It then leaks onto the avionics. Because the digital processor sits on the shelf, it allows water to wick in from underneath.

Change 1 to the MWO will raise the processor off the shelf to keep water from getting underneath.

But until the headshed comes up with a permanent fix for the leaky bay, take extra care not to direct water at the ventilation holes which help cool the avionics bay. Then inspect the bay for water and corrosion after you wash your bird or fly in the rain. Mop up any liquid on the avionics and the mounting area with a clean cloth and treat any corrosion you find.
